As you may be aware, I am the Insulation Improvement Project Liaison between the contractor and the HOA Board of Directors. The following is an update of the project with photos and captions as of January 24, 2019:

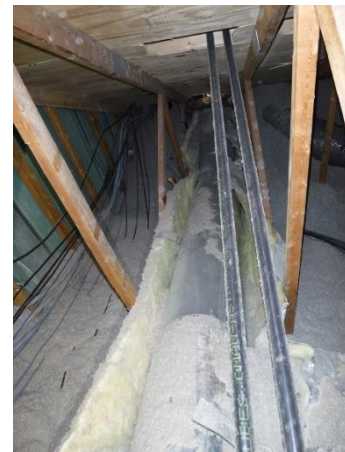
There is an 18-inch main trunk line that provides heating and cooling to most of the rooms in the unit. The trunk line insulation is improperly installed and has fallen off. This exposes large areas of uninsulated metal trunk line that radiates heat to the attic. Heat going into the attic requires the furnace to run longer to compensate for the heat loss while keeping the home at the desired temperature, thus increasing the heating bill.

*Trunk line insulation has completely fallen off.*

Trunk line repair has involved restoring the existing insulation to its proper position and taping the joint closed with aluminum tape. Then zip-ties are used to prevent the insulation from falling off again. The trunk line is then covered with fiberglass insulation, and lastly blow-in insulation is applied where ever needed.

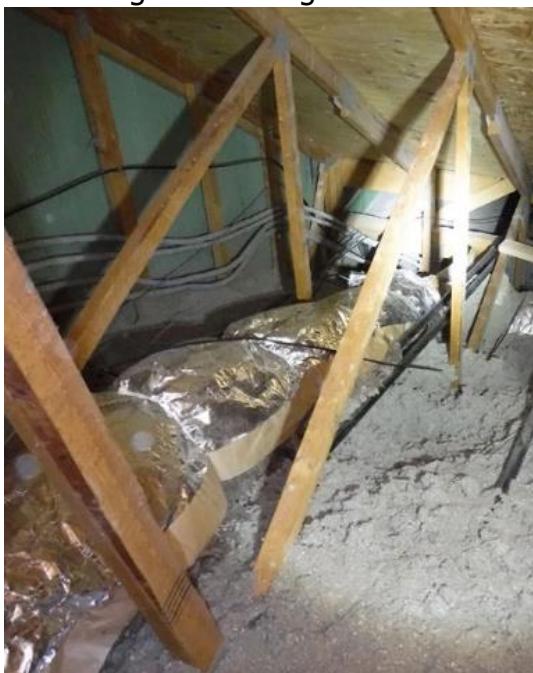
*Trunk line insulation position restored and secured with aluminum tape and zip-ties to prevent the insulation from falling off again.*

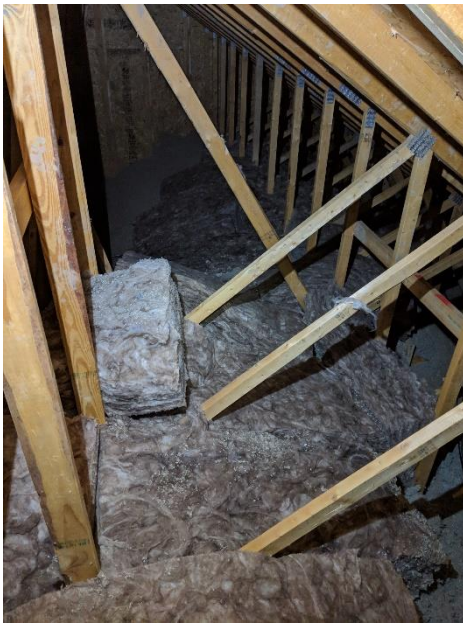
*Trunk line covered with fiberglass insulation.*

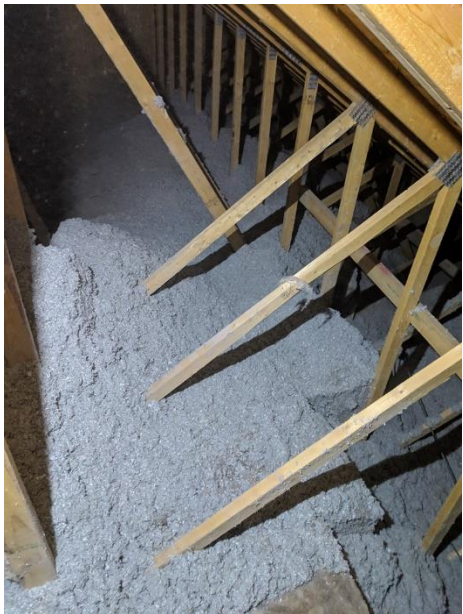
*Trunk line and attic area is covered with blown-in insulation where needed.*

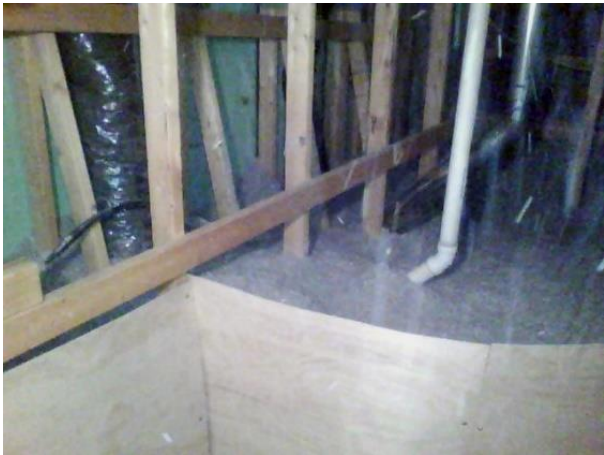
*Insulation is blown-in in the area above the furnace room.*

There is a significant amount of heat loss to the attic in the area above the furnace room because of poorly insulated ducts. A barrier was built around this area and filled with blown-in insulation.

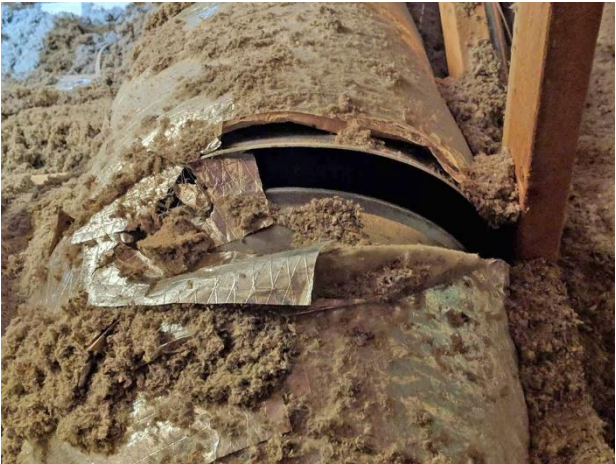
The worse situation so far is the main trunk line connection came apart in this unit allowing huge amounts of hot air to flow to the attic. After the repair, the owner stated that he could feel air coming from his registers for the first time. There will be a significant reduction in this owners heating and cooling bills.

*This is the open trunk line.*

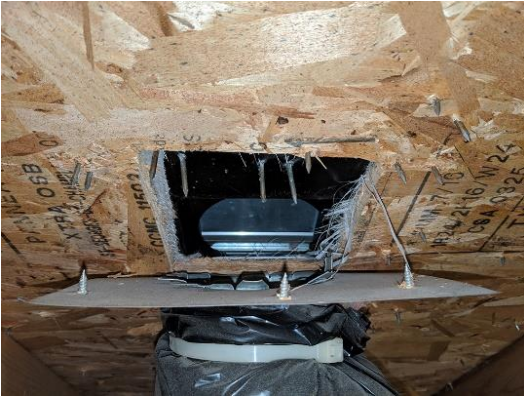
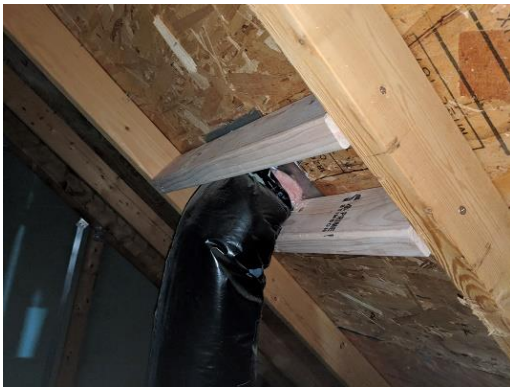
Numerous problems have been discovered that were outside the scope of the project. Here is one example where the bathroom vent had detached from the roof. Another is where the Tyvek under the shingles covered the ridge vent rendering it useless. The contractor is repairing such issues when found.

*This is the detached bathroom vent and the repair.*

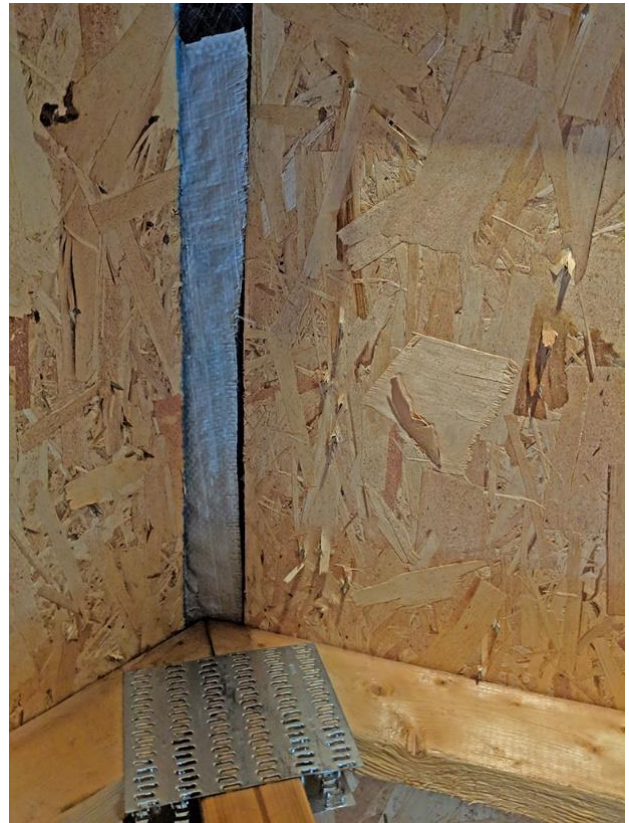
*Blocked ridge vent. Functional ridge vents are essential for providing ventilation of the attic.*
